SOME METALLOGRAPHIC RESULTS FOR BRUSH BRISTLES AND BRUSH SEGMENTS
OF A SHROUD RING BRUSH SEAL TESTED IN A T-700 ENGINE

Robert C. Hendricks
NASA Lewis Research Center
Cleveland, Ohio

SUMMARY

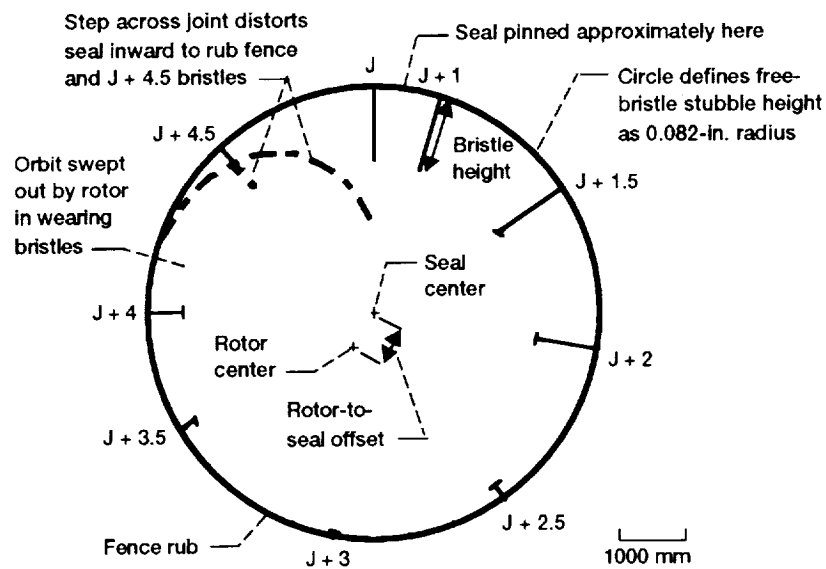
Figure 3.—Post-test turbine shroud wear pattern. From reference 1.

Hendricks et al. (ref. 1) reported the results of a T-700 engine test. Details of the bristles (fig. 3(a)) show an ingrained wear pattern that is characteristic of a high spot in the rotor which cuts a shallow groove as the rotor wears the brush. The rotor also ran eccentric with respect to the seal, and the blind installation made it difficult to assess intermediate states of wear or the health of the brush and the turbine shroud/brush interface.

(i) Wear track and fence rub.

(ii) Joint wear track.

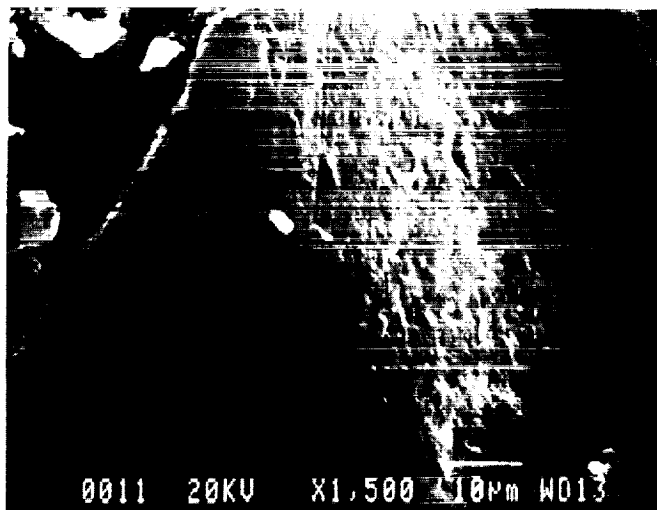
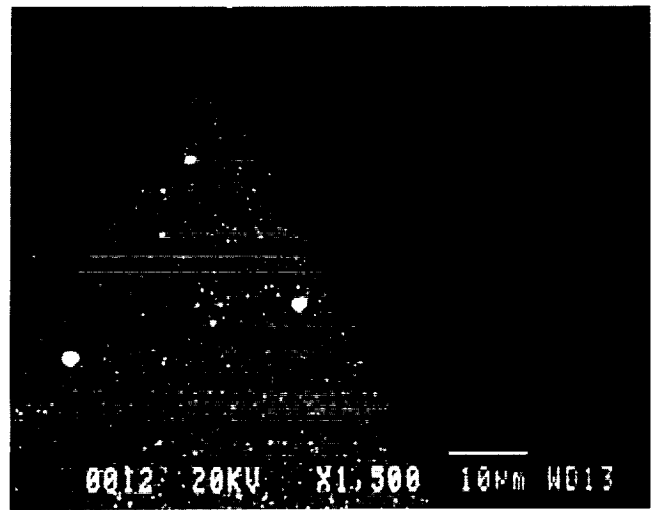
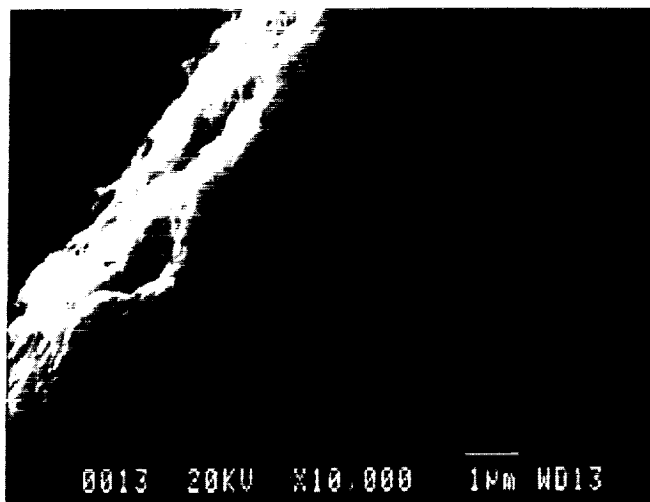
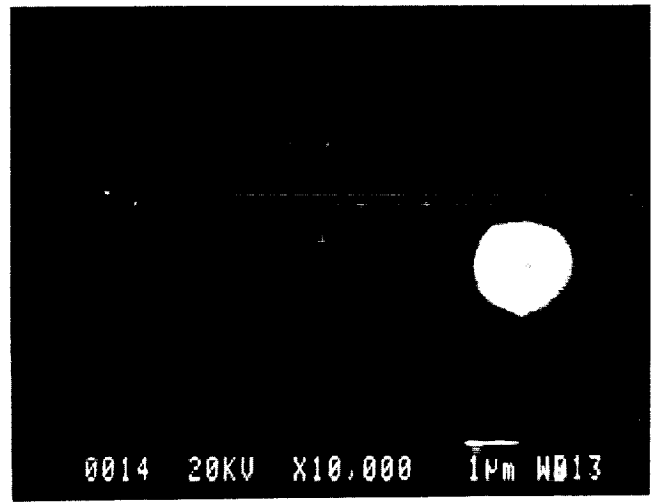
Figure 7.—Magnification of bristle tip wear surface and element composition.

The wear marks and the pocked bristle tip (fig. 6) were examined at higher magnification (fig. 7). Backscatter images show heavy atomic particles as bright spots and lighter weight elements as dark spots. Secondary electron images show tungsten but at a lesser brightness. Backscatter tends to change with geometry and higher magnification and wax mounting effects must be differentiated, but the interface wear marks show clearly. The bright spots are tungsten rich as noted by the element spectra, and the

spot on figure 7 is a beam concentration spot obtained by energy-dispersive spectroscopy of a bright tungsten-rich region.

At resolutions of 10 000X, there is no apparent change in tungsten at the bristle edge but there is possibly a small amount of titanium, which would represent a transfer from the rotor (rotor scrapings are discussed later). Again little evidence of resolidification but more evidence of oxide scale is noted.

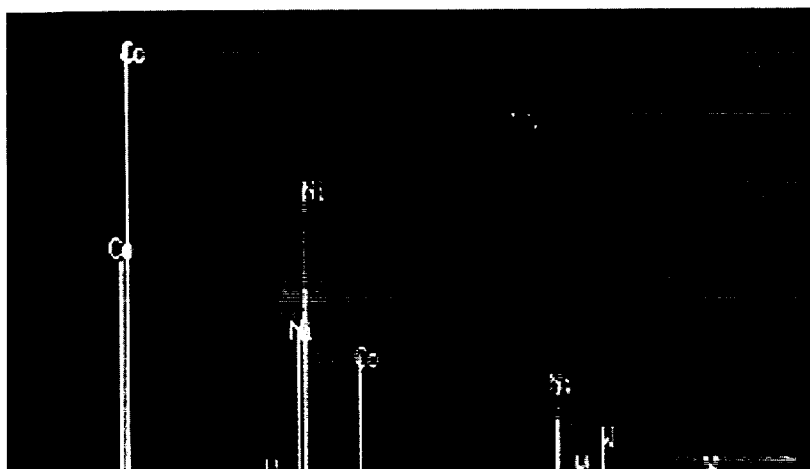
The bristle element spectra are dominated by cobalt, chromium, and tungsten lines representative of a cobalt-based alloy such as Haynes 25 (table I). Most spectra show oxide scale and little material transfer from the René 80 rotor (table I) to the bristles. However, increases in nickel and molybdenum (fig. 12) illustrate that some material transfer from the rotor to the bristle tips did occur. Nevertheless, scrapings from the René 80 rotor-bristle wear track (fig. 13; see also fig. 3(b)) were rich in cobalt, which is characteristic of Haynes 25 transfer to the rotor. Therefore, the sacrificial elements were the Haynes 25 bristles, as designed.

Figure 12.—Material transfer from René 80 rotor to Haynes 25 bristle.

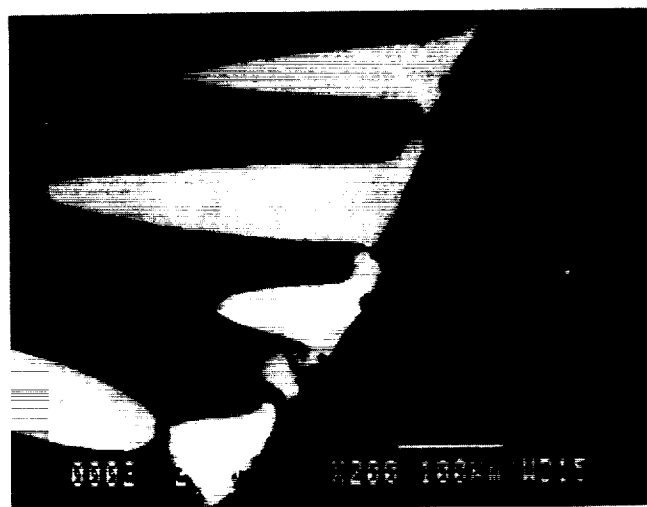
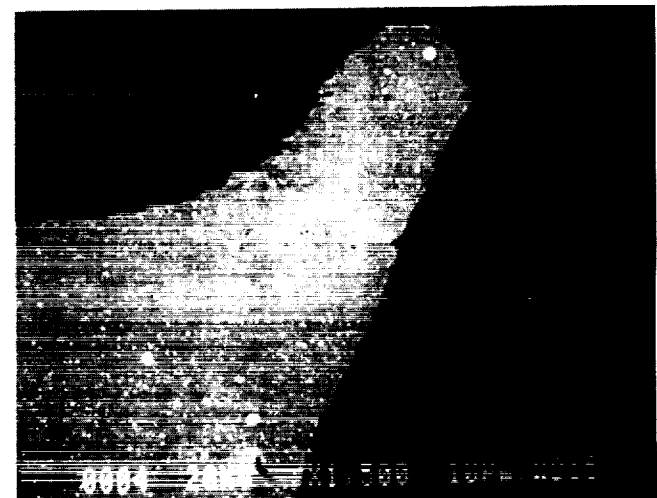
Figure 21.—Concluded.

Some of the pitting in brush segment 2 (fig. 21) may be due to electric discharge cutting of the sections, with the bristles investigated too near that interface. The polishing plane and the bristle planes are not all aligned and bristle tips are shown along with some bristles in the polishing plane. It is evident that the last bristle row is bent under the fence, but not so evident is when it happened. Backscattering electron photographs show uniform distribution of tungsten spots, some oxide formation, and some local fracturing of the smeared bristle tip. Color element traces show tungsten-rich white spots, oxide formation and the bristle matrix. The chromium diminished as the oxide increased or was leached out of the matrix. A closeup of the fence surface is shown as figure 21(b).

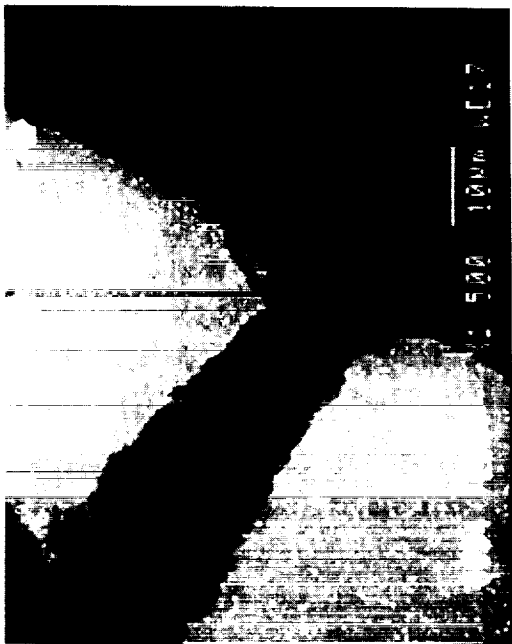
Figure 22.—Sets of information for brush segment 3.

Brush segment 3 (fig. 22) shows some evidence of melting and material debris from the backing plate or from the weld interface. The melt region is rich in redistributed tungsten, a factor that may have to be reevaluated as a manufacturing procedure. The color element traces show oxide formation between two bristles.

(ii) Melt near bristle attachment.
